# Supporting Info: Extraction of Moderate Risk Items from Annual Reports

**Date:** 6<sup>th</sup> February 2025

**To:** Leisure & Recreation Committee

## Barnum Court

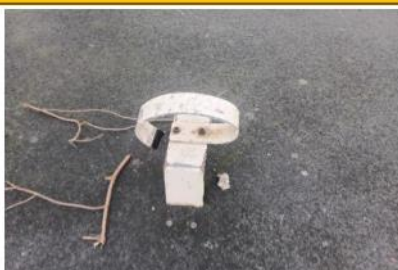
| 12 - Moderate Risk | |
|---|---|
| <b>Finding 1</b><br>The item has missing component(s) - Consider replacing missing components | |

New springer top for Barnum Court

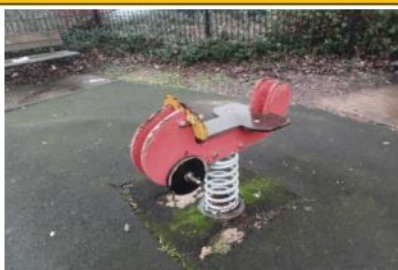
| 15 - Moderate Risk | |
|---|---|
| <b>Finding 1</b><br>The end of handgrips and/or footrests have a cross section of less than 15cm <sup>2</sup> and fail to meet the requirements of BS EN 1176 Part 6 - Monitor - No action given the risk assessment | <b>Finding 2</b><br>The paintwork on the spring has been damaged or worn exposing the metal underneath which is rusting - Treat any rusting components and repaint |
| <b>Finding 3</b><br>There is moderate damage to the surface - Repair the damaged areas of surfacing | <b>Finding 4</b><br>There are areas or parts of the timber on the structure that have rotted - Replace all affected timbers |
| <b>Finding 5</b><br>There is/are bolt cap covers missing or damaged on the item - Replace missing or damaged bolt cap covers | <b>Finding 6</b><br>A hand grip has been severely damaged - Repair or replace the item |

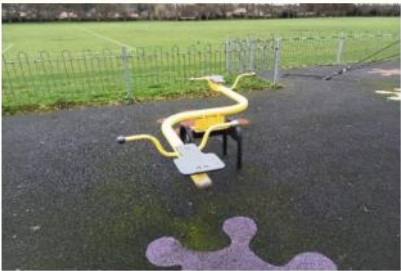
| <b>Finding 1</b><br>There is or are fixings missing on the item creating instability in the structure which has sheared other fixings - Replace all missing fixings | <b>Finding 2</b><br>Fixings are damaged and/or have sharp edges - Repair or replace as required |
| <b>Finding 3</b><br>The seat has been damaged - Monitor for any further deterioration and replace as required | |

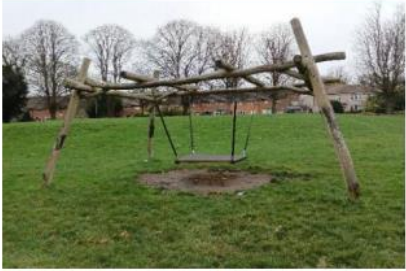
| <b>Finding 1</b><br>The fixings or components for this item were in excess of 2.5m above the standing surface and could not be fully accessed by the inspector. We have completed a visual inspection of the fixings from ground level but a maintenance inspection should be undertaken to assess the condition, security and wear of the components at intervals in accordance with the manufacturers recommendations. - Inspect in accordance with the manufacturers recommendations | <b>Finding 2</b><br>The seat connection cannot be inspected fully as the chain cover cannot be lifted - Cut the cover to allow access to the shackle and assess the wear |
| <b>Finding 3</b><br>The seat suspension cover has been damaged - Monitor for any further deterioration and replace as required | <b>Finding 4</b><br>The chain openings are in excess of the 8.6mm as recommended by BS EN 1176 - Monitor - No action given the risk assessment |
| <b>Finding 5</b><br>The seat has minor damage or wear - Monitor for any further deterioration and replace as required | <b>Finding 6</b><br>There is or are fixings missing on the item - Replace all missing fixings |
| <b>Finding 7</b><br>A number of secondary safety fixing(s) have worked loose - Secure all loose fixings | <b>Finding 8</b><br>There is some notable evidence of chain wear - Monitor for any further deterioration and replace when 40% worn |

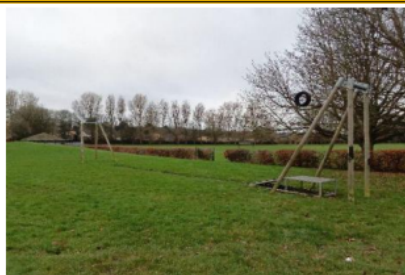
We have completed a visual inspection of the suspension links, cable and fixing points from ground level, however it is not possible to fully inspect these areas without either hiring equipment to gain access or removing the cable and suspension and inspecting at ground level. We recommend that the main cable and fixing security is thoroughly inspected at least in accordance with the manufacturers recommendations to check for wear, damage, security or internal rusting; this will help to ensure the continued safe use of the equipment - Inspect in accordance with the manufacturers recommendations

The seat and suspension are missing from the Cableway; ensure that the traveller is secured against use or removed to prevent misuse - Refer to the site operator

There is or are fixings missing both sides of the framework - Replace all missing fixings

There are areas or parts of the timber on the structure that have rotted - Replace all affected timbers

There is some evidence of rot in the timber posts - Monitor for any further deterioration and replace as required

The grass mats are silted up, the soil is compacted and the area will become very slippery when the soil is wet. - Reinstate as required

A grass matrix tile has been installed upside down - Reinstall the grass matrix tile the correct way up

The edges of the grass mat surface are raised / lifting above the surrounding surface - Tuck in or pin edges of grass mats as per the API Code of Practice to remove trip hazards

There are trip hazards at the edges of the surface - Remove trip hazard

There is offensive graffiti present - Remove as soon as practicable

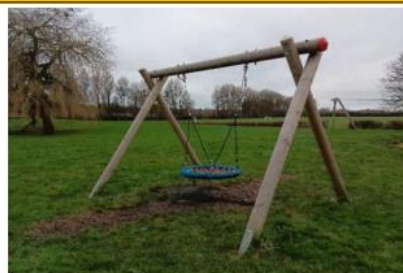
There is moderate damage to the surface - Repair the damaged areas of surfacing

Fixing Pins have been installed in the impact areas of the grass mats - Remove pins from impact areas

The ropes/nets are worn/damaged in places - Monitor for any further deterioration and repair or replace as required

There is or are fixings missing on the secondary support chains - Replace all missing fixings

A number of fixing(s) have worked loose - Secure all loose fixings

There is/are bolt cap covers missing or damaged on the item - Replace missing or damaged bolt cap covers

There is some graffiti present - Remove the graffiti

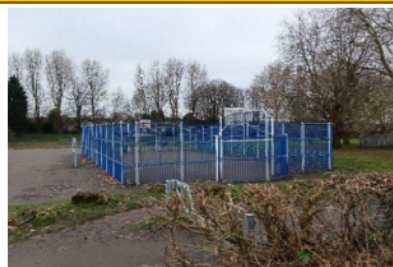
A clearly visible facility sign should be provided in a prominent position with the wording as detailed BS EN 15312- the equipment is not intended for children less than 3 years old- the warning - Do not climb on the framework or nets- the warning - Do not hang on the ring (if provided)- the warning - Do not wear rings or other jewellery- name and telephone number of the administrator- number to call in case of accident - Provide signage to BS EN 15312

The item fails to meet the requirements of BS EN 15312 4.4.2.1 head and neck entrapment in the framework - Monitor - No action given the risk assessment

There is or are fixings missing on the backboard - Replace all missing fixings

The net is damaged and requires removal / replacement - Replace

The item has missing component(s) rubber spacer - Consider replacing missing components

There is some tree debris on the surfacing - Remove and maintain

There is algae, silt or moss growth on the surface resulting in slippery conditions - Clean and treat appropriately

There is some graffiti present - Remove the graffiti

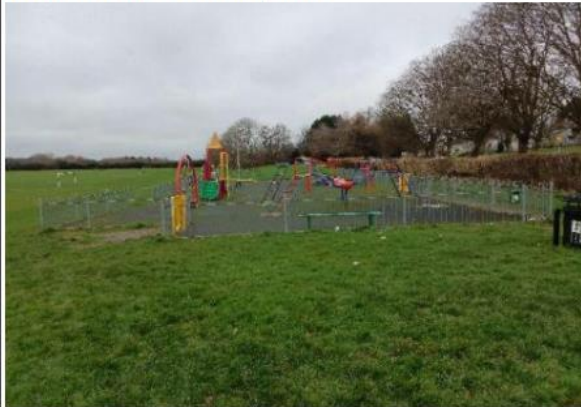
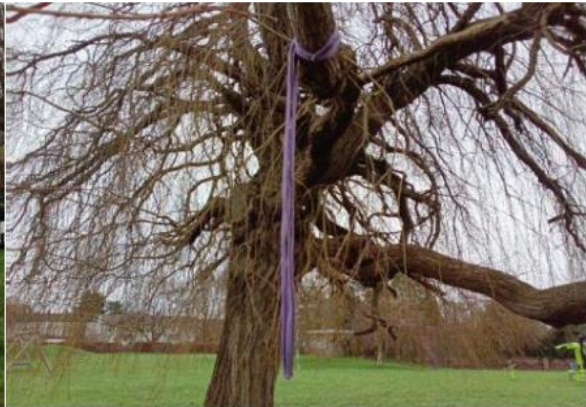
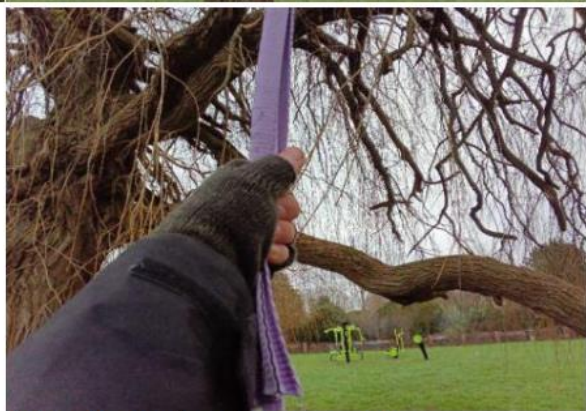
12 - Moderate Risk (Finding 2)

**Finding:** There is a self-made rope or tyre swing present. This type of construction is not recommended unless the trees / branches and connections have all been independently tested and checked by a competent person for sufficient structural stability, a suitable impact attenuating

**Action:** Remove if requirements are not met

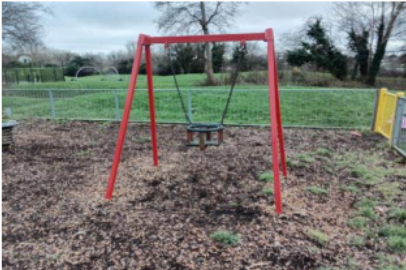
| <div> 12 - Moderate Risk </div> | | |
|---|---|---|
| <b>Finding 1</b><br>The surface has eroded and the foundations are exposed - Reinstate surrounding surfaces to cover the foundations | <b>Finding 2</b><br>The seat is severely damaged and requires replacing - Replace damaged seat | |
| <b>Finding 3</b><br>The chain openings are in excess of the 8.6mm as recommended by BS EN 1176 - Monitor - No action given the risk assessment | <b>Finding 4</b><br>There is some wear to the shackles. - Monitor for any further deterioration and replace when 40% worn | |
| <b>Finding 5</b><br>The bush / bushes is / are worn or missing - Replace worn or missing bushes | <b>Finding 6</b><br>The design of the access pathways forces users to encroach on the free space of the equipment - Monitor the risk assessment regularly and modify the design if required | |

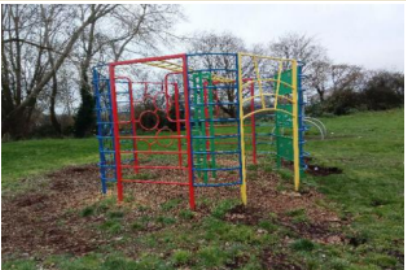
| <div> 12 - Moderate Risk </div> | | |
|---|---|---|
| <b>Finding 1</b><br>The depth of the loose fill surfacing is lower than the recommended depth specified in BS EN 1176 for a fall height over 2.0m. A minimum depth of 400mm is recommended (including an extra 100mm to allow for compaction and displacement as per BS EN 1176 Part 1 - Table 4) - Top up loosefill to recommended levels | <b>Finding 2</b><br>The foundations forms a hard object within the impact area of the equipment in contravention of the requirements of BS EN 1176 Part 1 - Top up loose fill levels to recommended levels to cover foundations | |
| <b>Finding 3</b><br>The chain openings are in excess of the 8.6mm as recommended by BS EN 1176 - Monitor - No action given the risk assessment | <b>Finding 4</b><br>The connecting lugs are showing signs of wear - Monitor for any further deterioration and repair as required | |
| <b>Finding 5</b><br>There is some notable evidence of chain wear - Monitor for any further deterioration and replace when 40% worn | <b>Finding 6</b><br>There are holes in surface that may have been created purposely by users. - Infill to provide a sound reasonably level surface. | |
| <b>Finding 7</b><br>There is weed / vegetation growth within the surface - Remove weed / vegetation growth | <b>Finding 8</b><br>There is some graffiti present - Remove the graffiti | |

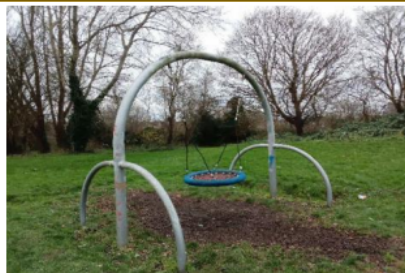
The depth of the loose fill surfacing is lower than the recommended depth specified in BS EN 1176; the free height of fall of the equipment is less than 2.0m and a minimum of 300mm depth should be provided (including an extra 100mm to allow for compaction and displacement as per BS EN 1176 Part 1 - Table 4) - Top up loose fill surfacing to recommended levels to cover base

Swings of this design should have a secondary safety device fitted to prevent collapse of the seat in the event of a joint failure to meet the requirements of BS EN 1176 Part 2 - Consult with manufacturer and consider providing a secondary safety device where possible

There is some evidence of fire damage to the item - Monitor for any further deterioration and repair as required

The bush / bushes is / are worn or missing - Replace worn or missing bushes

There is offensive graffiti present - Remove as soon as practicable

The concrete surface forms a hard object within the impact area of the equipment in contravention of the requirements of BS EN 1176 Part 1 - Top up loose fill surfacing levels to recommended levels

The bush / bushes is / are showing signs of wear - Monitor for any further deterioration and replace as required

The connecting links are in excess of 8.6mm and less than 12mm and fail the requirements of BS EN 1176 Part 1; clause 4.2.13, Chains - Monitor - No action given the risk assessment

The connecting lugs are worn - Replace lugs or all affected components

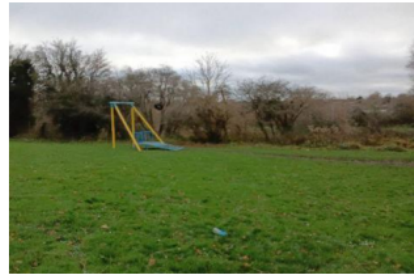
We have completed a visual inspection of the suspension links, cable and fixing points from ground level, however it is not possible to fully inspect these areas without either hiring equipment to gain access or removing the cable and suspension and inspecting at ground level. We recommend that the main cable and fixing security is thoroughly inspected at least in accordance with the manufacturers recommendations to check for wear, damage, security or internal rusting; this will help to ensure the continued safe use of the equipment - Inspect in accordance with the manufacturers recommendations

The cableway seat has been severely damaged - Repair or replace the seat as required

The dampening spring or tyre is damaged or broken on the item - Replace spring or tyre

There is some notable evidence of chain wear - Monitor for any further deterioration and replace when 40% worn

The surface has eroded and the foundations are exposed - Reinststate surrounding surfaces to cover the foundations

The seat connection cannot be inspected without dismantling the seat - Dismantle the seat to inspect the seat connection for wear

The cable is under-tensioned / sagging - Re-tension cable, ensuring that the speed does not exceed 7 metres per second in use and the suspension does not exceed 45 degrees at point of impact once adjusted

The height of the seat is less than 350mm when loaded and does not meet the requirements of BS EN 1176 Part 4 - Ensure the seat is a minimum of 350mm above ground level when loaded with 69.5kg

The item has missing component(s) timber guide planks - Replace missing components

The grass mats are silted up and the soil is compacted; this may have an effect on the impact absorbing properties of

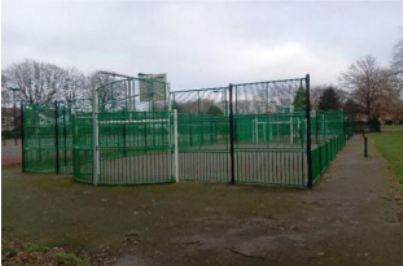
| 16 - High Risk | |
|---|---|
| <b>Finding 1</b><br>A clearly visible facility sign should be provided in a prominent position with the wording as detailed BS EN 15312- the equipment is not intended for children less than 3 years old- the warning - Do not climb on the framework or nets- the warning - Do not hang on the ring (if provided)- the warning - Do not wear rings or other jewellery- name and telephone number of the administrator- number to call in case of accident - Provide signage to BS EN 15312 | <b>Finding 2</b><br>The item fails to meet the requirements of BS EN 15312 4.4.2.1 head and neck entrapment in the framework - Monitor - No action given the risk assessment |
| <b>Finding 3</b><br>There is/are finger entrapments in the framework and the item fails to meet the requirements of BS EN 15312 Clause 4.4.2.2 Entrapment of fingers - Monitor - No action given the risk assessment | <b>Finding 4</b><br>There is/are finger entrapments in the framework and the item fails to meet the requirements of BS EN 15312 Clause 4.4.2.2 Entrapment of fingers - Provide insert to remove entrapment |
| <b>Finding 5</b><br>There is or are fixings missing on the panelling - Replace all missing fixings | <b>Finding 6</b><br>The item has missing component(s) rubber spacer - Consider replacing missing components |
| <b>Finding 7</b><br>There is or are fixings missing on the backboard - Replace all missing fixings | <b>Finding 8</b><br>The fence panel is missing 3 of 4 fixings the remaining fixings are loose - Secure panel and replace missing fixings |
| <b>Finding 9</b><br>A number of fixing(s) have worked loose - Secure all loose fixings | <b>Finding 10</b><br>The net is damaged and requires removal / replacement - Replace |
| <b>Finding 11</b><br>The fence is severely damaged in places - Repair or replace all affected sections | <b>Finding 12</b><br>There is some graffiti present - Remove the graffiti |

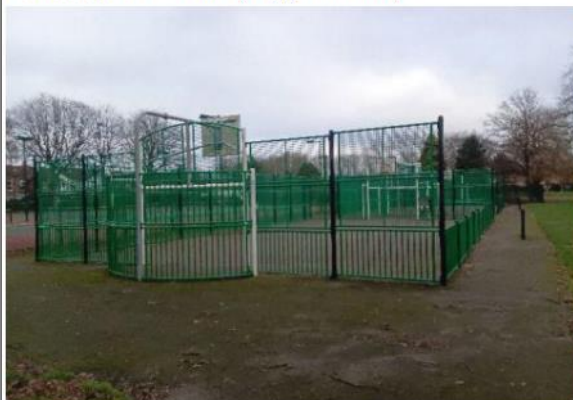
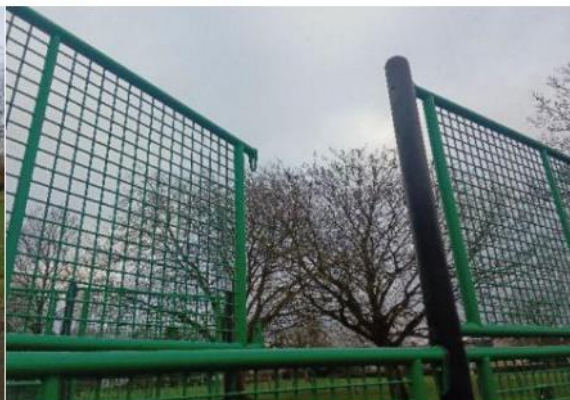
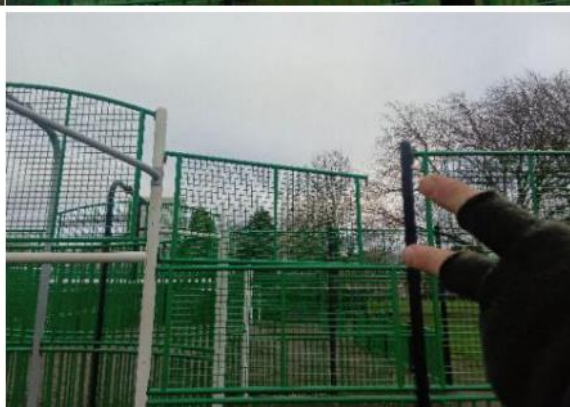
**16 - High Risk (Finding 8)**

**Finding:** The fence panel is missing 3 of 4 fixings the remaining fixings are loose

**Action:** Secure panel and replace missing fixings

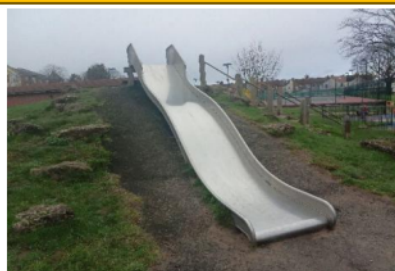
The boulders forms a hard object within the freespace of the equipment, in contravention of the requirements of BS EN 1176 Part 1 - Monitor - No action given the risk assessment

There are areas or parts of the timber on the structure that have rotted - Replace all affected timbers

The surface is lifting at the edges and creating trip points - Repair perimeter of surfacing to remove trip points

There are a number of dents in the slide surface - Monitor for any further deterioration and repair as required

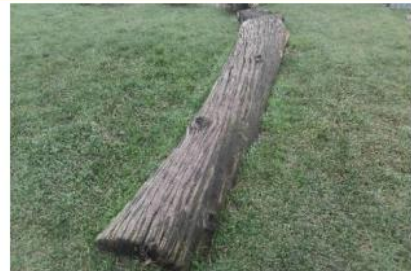
There are areas or parts of the timber on the structure that have rotted - Replace all affected timbers

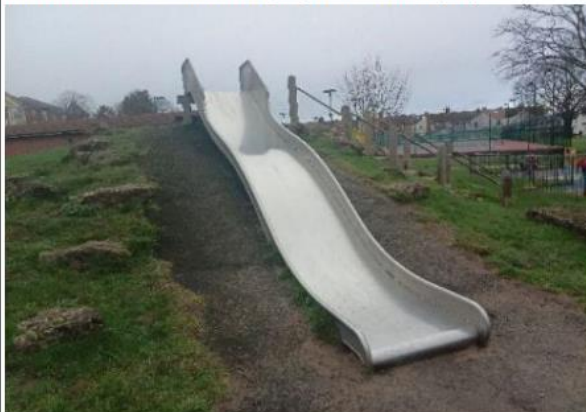
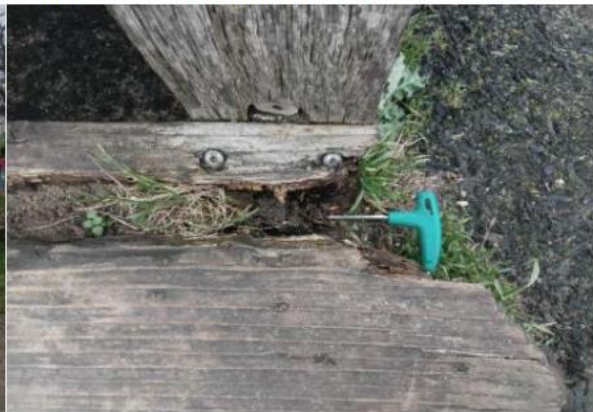
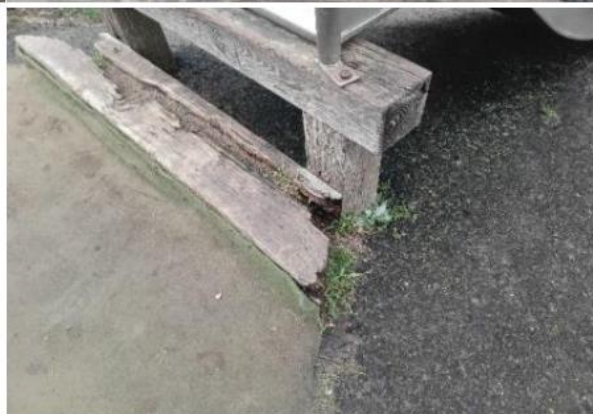
#### 12 - Moderate Risk (Finding 3)

**Finding:** There are areas or parts of the timber on the structure that have rotted

**Action:** Replace all affected timbers

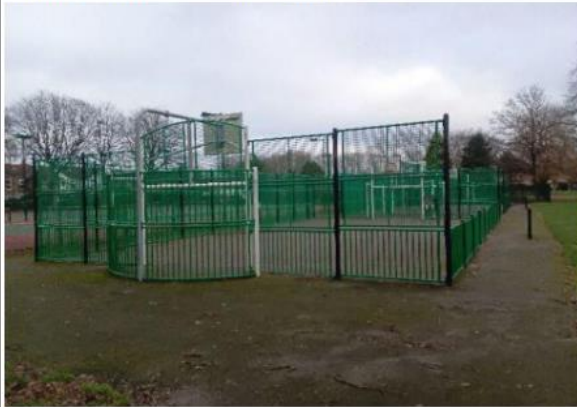
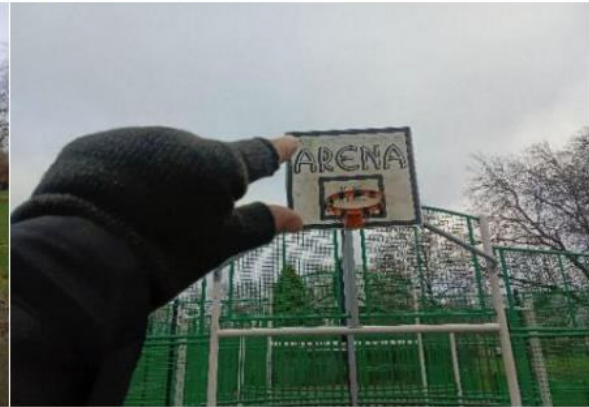
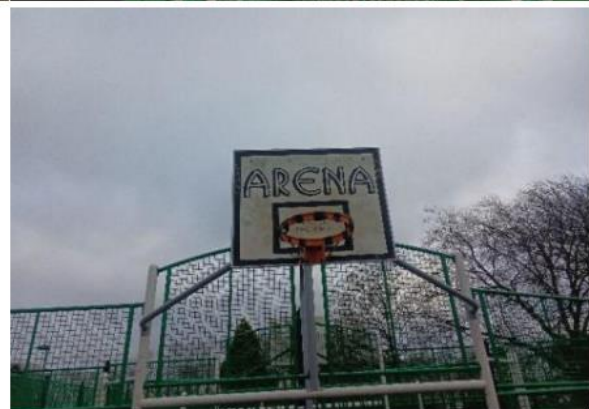
12 - Moderate Risk (Finding 7)

**Finding:** There is or are fixings missing on the backboard

**Action:** Replace all missing fixings

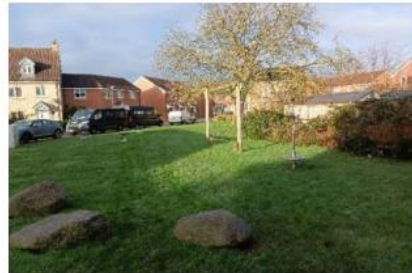
It is recommended that signage, with information including the site address, contact information for maintenance issues and emergency contact details are provided for the facility - Provide in accordance with the recommendations

NOTE - The area opens onto a road - Ensure a full and sufficient risk assessment has been undertaken and review regularly

There is a self-made rope or tyre swing present. This type of construction is not recommended unless the trees / branches and connections have all been independently tested and checked by a competent person for sufficient structural stability, a suitable impact attenuating surface is provided on the seat itself and the surface underneath and a separately documented risk assessment and control measures are in place. - Remove if requirements are not met

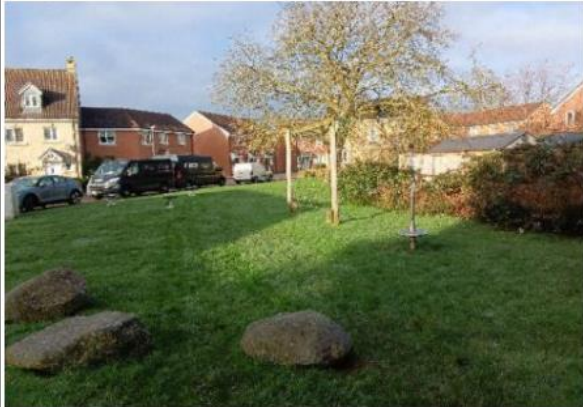
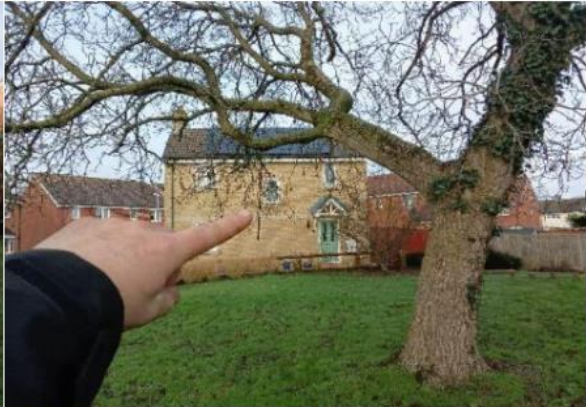
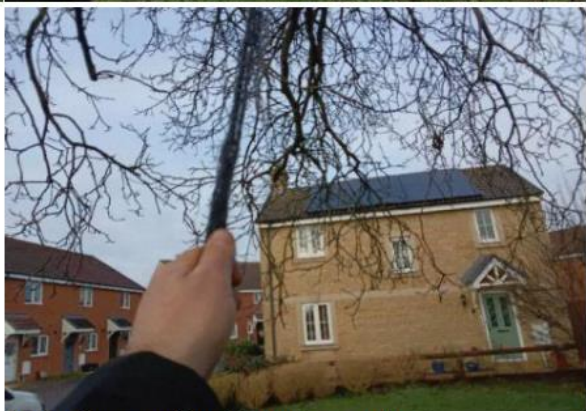
## 12 - Moderate Risk (Finding 3)

**Finding:** There is a self-made rope or tyre swing present. This type of construction is not recommended unless the trees / branches and connections have all been independently tested and checked by a competent person for sufficient structural stability, a suitable impact attenuating surface is provided on the seat itself and the surface

**Action:** Remove if requirements are not met
